**GOLETA SANITARY DISTRICT**  
**NPDES MONITORING PROGRAM**  
**2018 ANNUAL REPORT**

*Submitted: January 28, 2019*

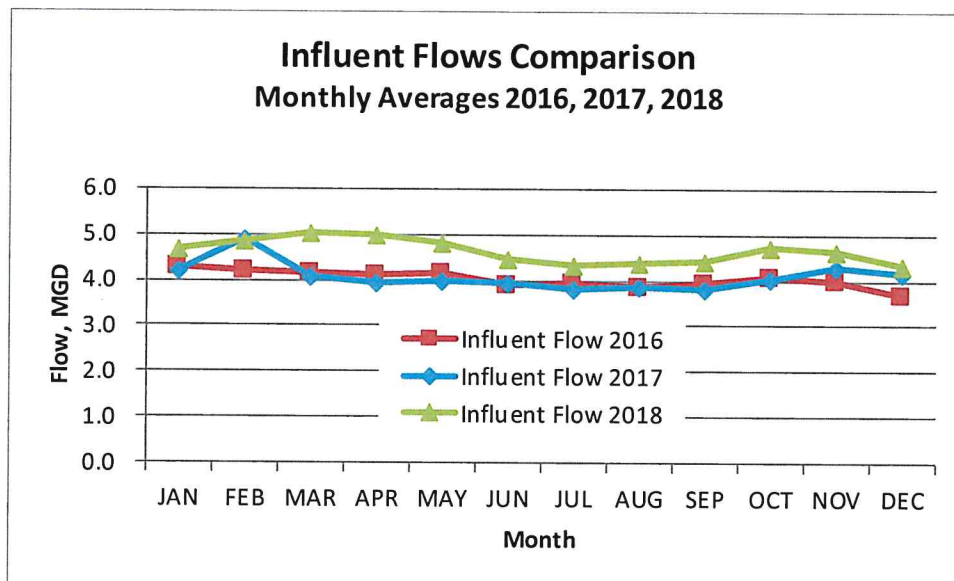
**Figure 2-1. Influent Flows Monthly Average Comparison for 2016, 2017 and 2018**

Overall, the average monthly influent flows for 2018 varied throughout the year, fluctuating from a low of 4.3 MGD in December to a high of 5.0 MGD in March. The decrease in average influent flow observed at the plant is likely due to water conservation implemented by residents in response to the drought conditions. See Figure 2-1 for a visual flow comparison.

The highest flows into the plant during 2018 occurred during the beginning of the year, and may be associated with heavy rains that occurred in March.

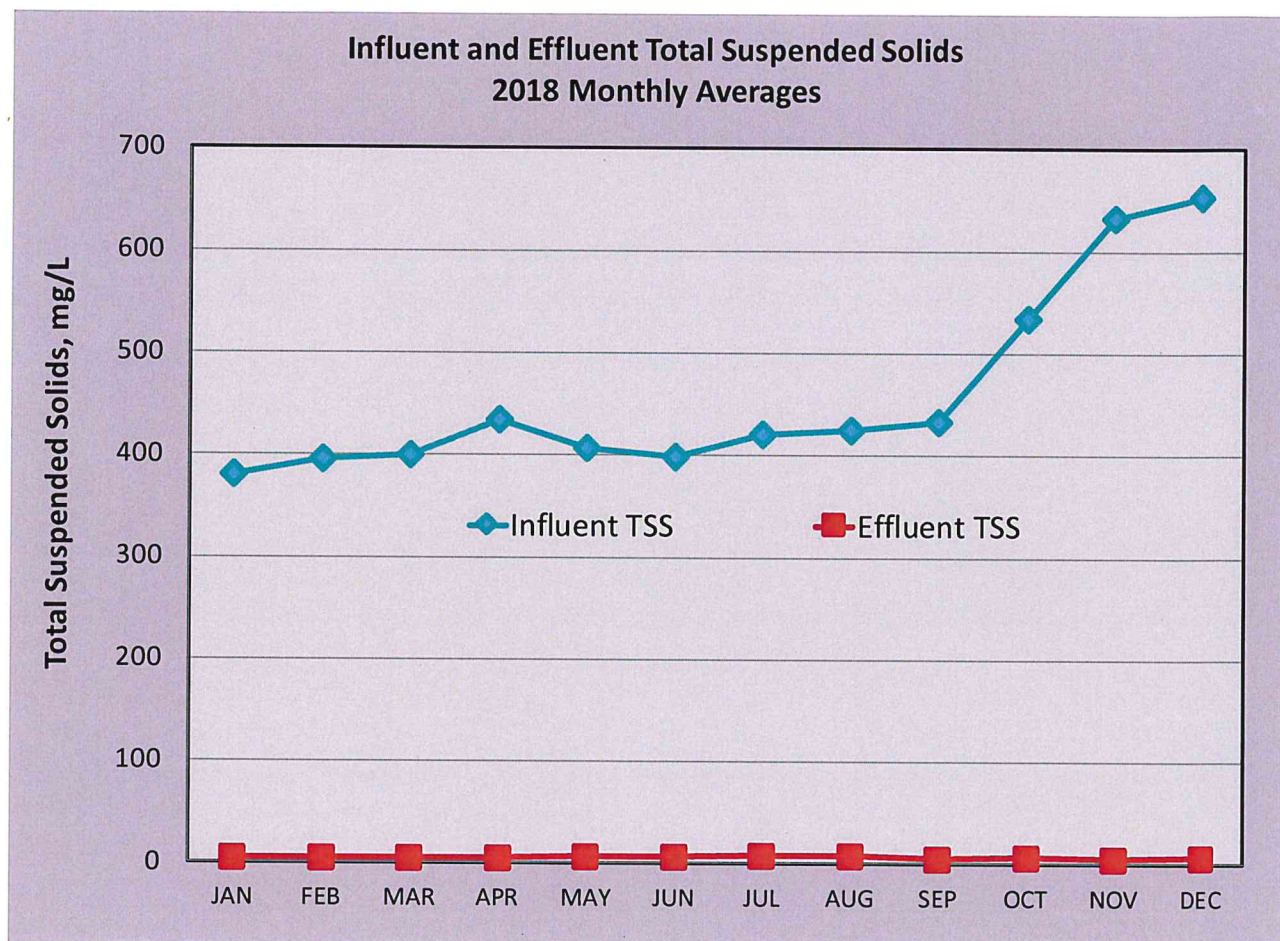
**Figure 2-3. Influent and Effluent Total Suspended Solids 2018 Monthly Averages**

Influent and effluent suspended solids were measured five days per week on 24-hour composite samples. The effectiveness of the treatment plant in removing suspended solids is demonstrated by the variation of influent solids versus the low-level and consistent output of effluent solids (see Figure 2-3). Influent suspended solids concentrations averaged 459 mg/L for the year an increase of about 22% from the 2017 annual average of 356 mg/L. Figure 2-3 shows a spike in concentration of suspended solids that occurred during October which continued to increase throughout the remainder of the year. The treatment process reduced the concentration of total suspended solids in the effluent to an annual average of 6.1 mg/L an 8% annual decrease of the 6.6 mg/L average of 2017.

All effluent 30-day monthly averages were well below the 30-mg/L monthly average limitation. Overall removal efficiency for the year was an average of 98.6 percent, see Table 2-1.

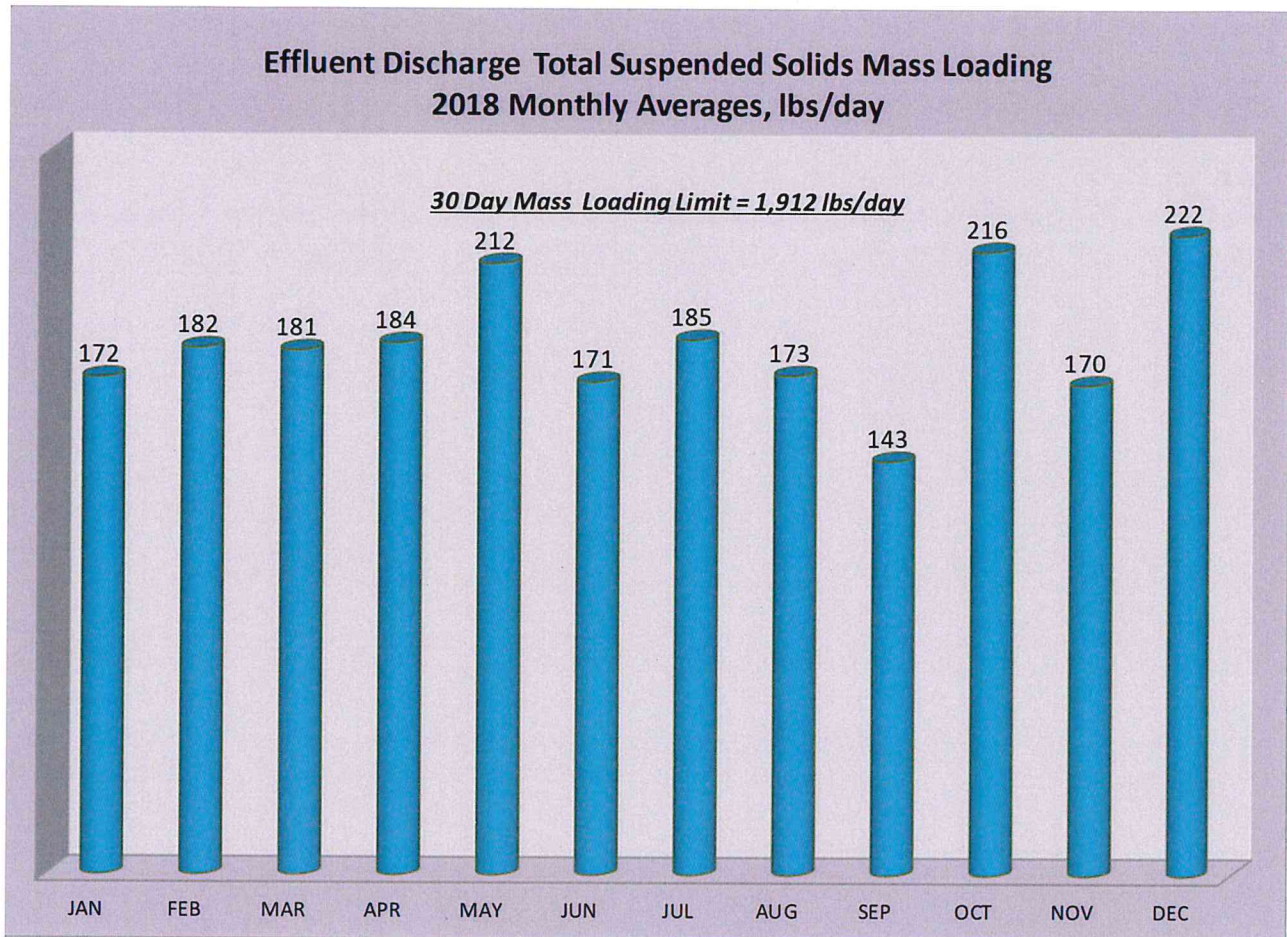
**Figure 2-4. Effluent Discharge Total Suspended Solids Mass Loading, 2018 Monthly Averages, lbs/day**

Average monthly suspended solids mass loading rates for 2018 are represented graphically in Figure 2-4. The mass emission limit is based on average dry weather flow (ADWF) and is a limit applied to dry weather flows (DWF). There is no limit for mass emissions on wet weather flows.

The maximum average monthly mass emission loading for 2018 occurred in December at a high of 222 lbs/day, which is approximately 12 percent of the permitted monthly 30-day average limit of 1,912 lbs/day. Loading rates were well below the discharge limits throughout the year.

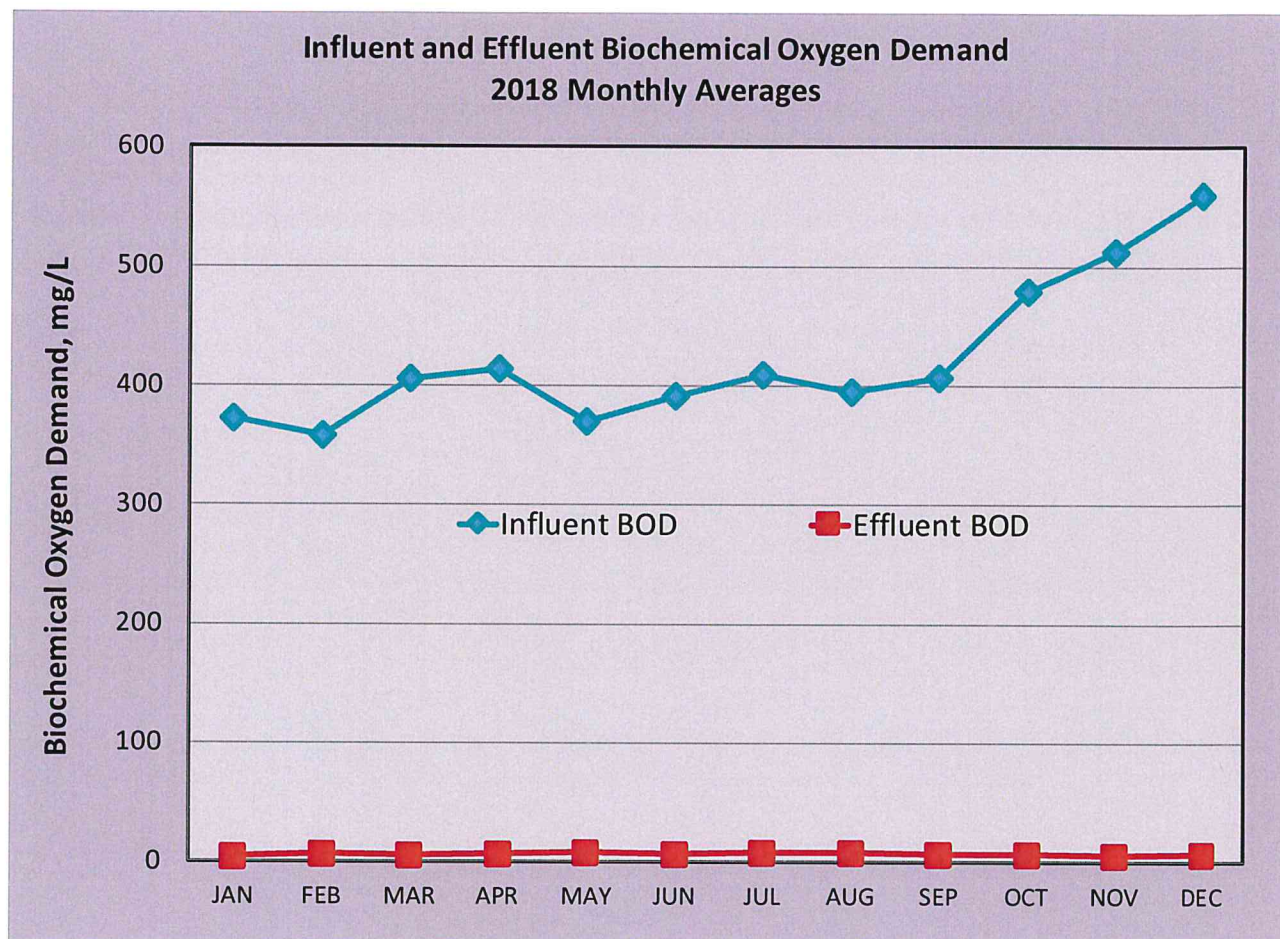
Figure 2-5. Influent and Effluent Biochemical Oxygen Demand 2018 Monthly Averages

During 2018 influent BOD averaged 423 mg/L showing an increase of 17% from the annual influent average of 352 for 2017. The influent BOD varied throughout the year, ranging from a monthly average low of 358 mg/L in February to a high of 560 mg/L in December.

A small variation in the monthly average final effluent BOD concentration was observed throughout the year with the annual average of 6.8 mg/L and the range extending from a low of 4.7 in January to a high of 8.4 in July, (Table 2-1). The difference between influent and effluent BOD represents an overall removal rate of 98.3 percent.

The NPDES R3-2017-0021 permit limits are an average of 30 mg/L and weekly average of 45 mg/L. All BOD NPDES limitations were achieved throughout the year.

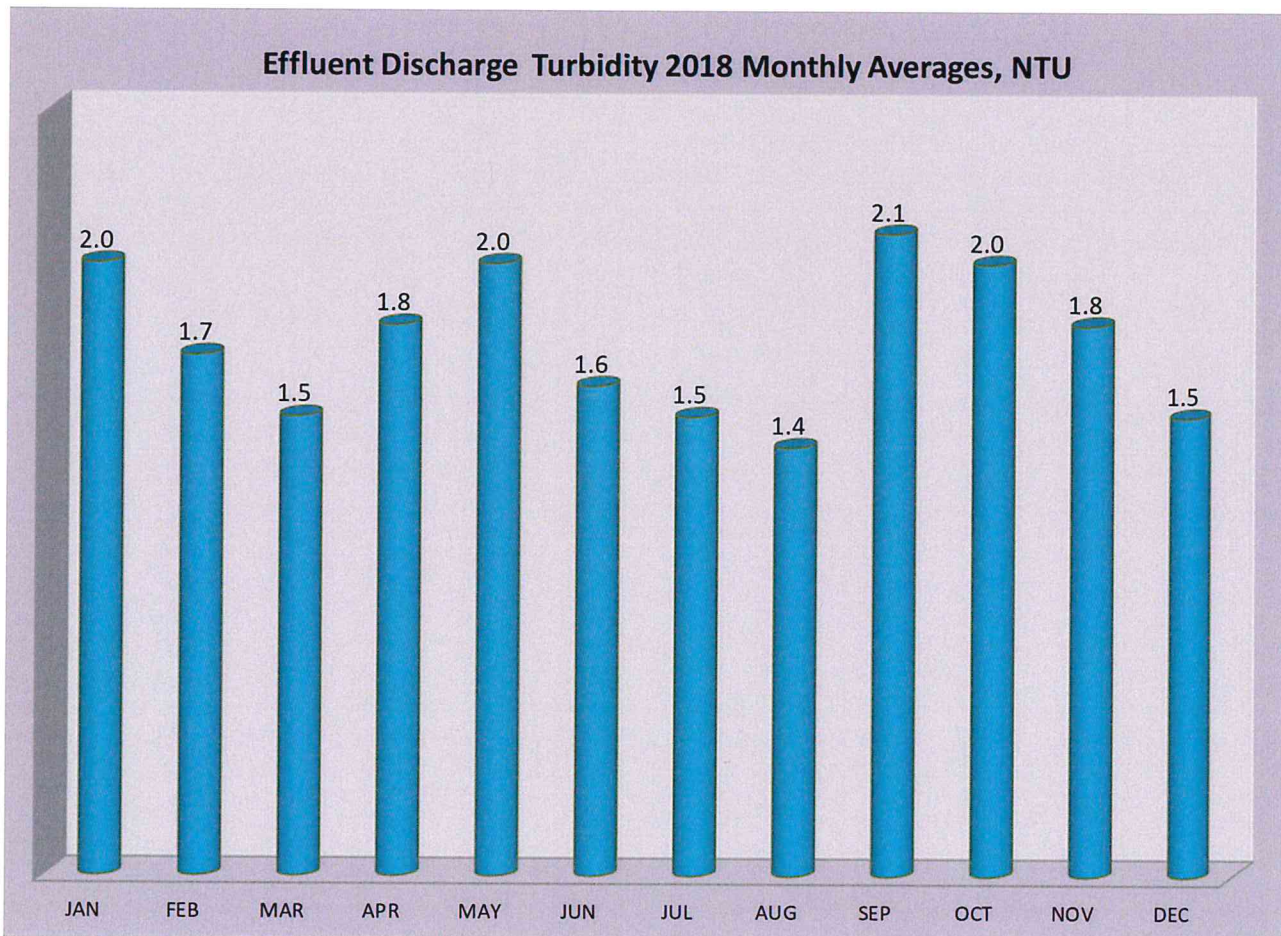
**Figure 2-6. Effluent Discharge Turbidity 2018 Monthly Averages, NTU**

Effluent turbidity was monitored five days per week. The permit limitations for effluent turbidity consists of a monthly average of 75 Nephelometric Turbidity Units (NTU), a weekly average of 100 NTU, and a maximum at any time limitation of 225 NTU. Effluent turbidity data are shown graphically in Figure 2-6. The maximum value at any time, 3.4 NTU, occurred on September 16 which was still well below the effluent limits. Monthly averages ranged from a low of 1.4 NTU to a high of 2.1 NTU. All values were significantly below their respective permit limitations.

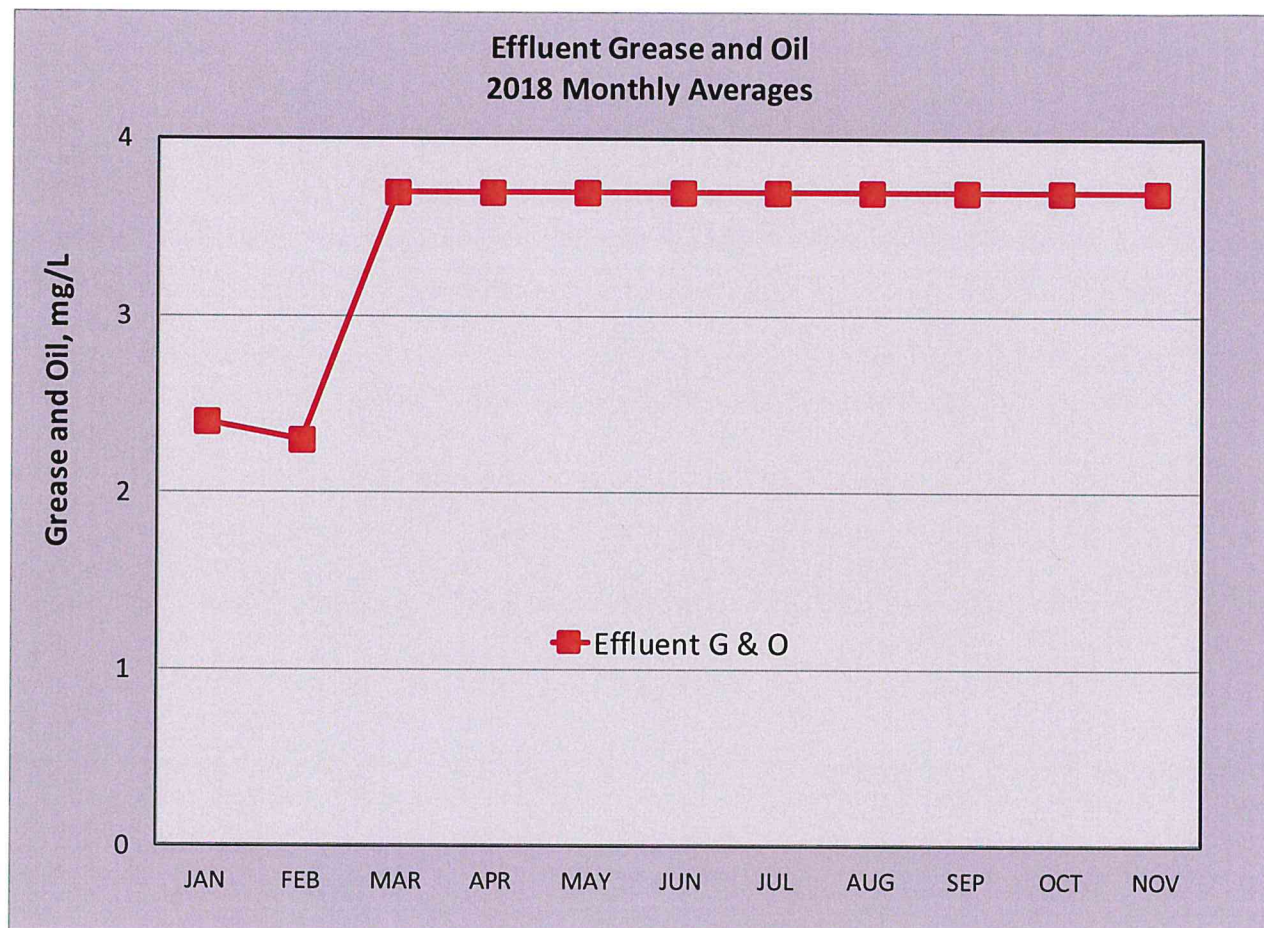
**Figure 2-7. Effluent Grease and Oil 2018 Monthly Averages**

Effluent oil and grease were monitored weekly. Monthly average results are shown graphically in Figure 2-7. Prior to August 2007 Freon was the solvent used in the standard method to extract oil and greases from water samples. According to EPA regulations, in August 2007 the GSD laboratory ceased using Freon as the extraction solvent and began using hexane as the required solvent. The District continued to use the liquid-liquid extraction method, the only change at this time was the solvent. In December 2010, the GSD laboratory began analyzing for oil and grease using the approved standard solid phase extraction (SPE) method. The current permit, R3-2017-0021, eliminated the influent oil and grease monitoring requirement.

Effluent grease and oil concentrations were very low and consistent during 2018. All monthly, weekly, and maximum permit limits were met. Mass emissions values ranged from a monthly average low of 78.7 lbs/day in February to a high of 136 lbs/day in March. Both are well below the permit limitation of 1,590 lbs/day. Monthly average oil and grease concentrations in the effluent ranged from 2.4 mg/L to <3.7 mg/L which is below the method detection limit. The method detection limit changed to 3.7 in February 2018 because a new value was calculated. See Table 2-2 for a visual representation of the monthly average results. All permit limitations for effluent oil and grease were met during 2018.
