# **GOLETA SANITARY DISTRICT**

## **NPDES MONITORING PROGRAM**

### **2025 ANNUAL REPORT**

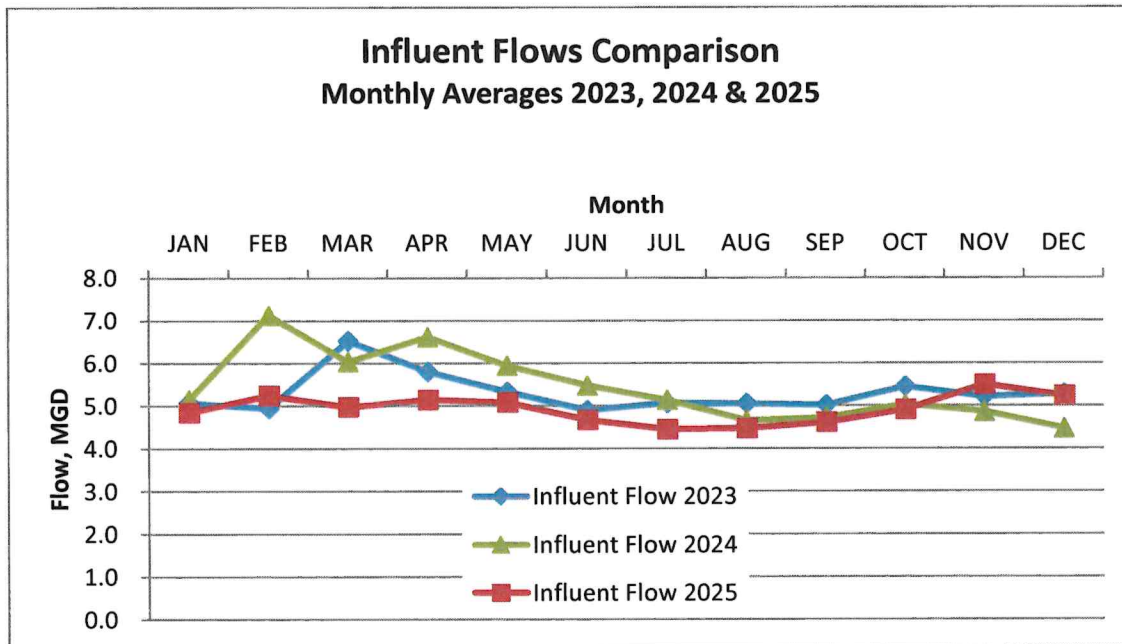
**Figure 2-1. Influent Flows Monthly Average Comparison for 2023, 2024 and 2025**

Overall, the average monthly influent flows for 2025 had minor seasonal variations throughout the year, fluctuating from a low of 4.44 MGD in July to a high of 5.48 MGD in November. See Figure 2-1 for a visual flow comparison.

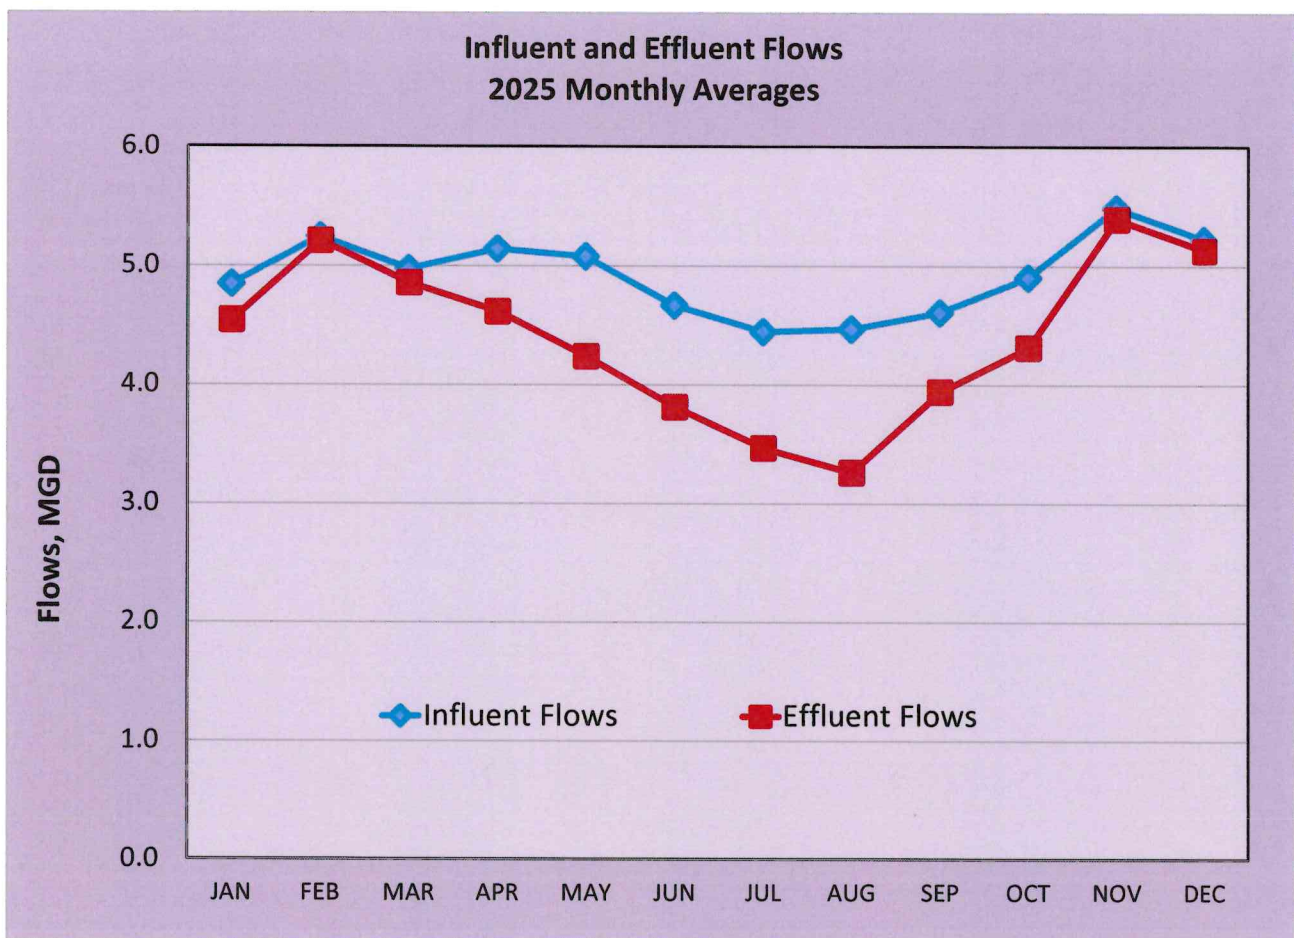
**Figure 2-2. Influent and Effluent Flows 2025 Monthly Averages**

Figure 2-2 shows the monthly average influent and effluent flows for 2025. Higher wastewater effluent flow generally occurs during the winter months when influent flow is also the highest and recycling is minimal. The most important factor contributing to fluctuations in the effluent flow is the amount of wastewater that is processed into reclaimed water and used for irrigation.

The lowest effluent flow occurred during August when the average amount of flow discharged to the Pacific Ocean dropped to 2.7 MGD. The variations in the monthly average effluent flow seen in 2025 fluctuated from a low of 3.3 MGD in August, when the daily production of reclaimed water averaged 1.50 MGD for the month to a high of 10.3 MGD during December when the reclaimed facility was off line and a significant rain event occurred. Figure 2-2 depicts the influent and effluent flows and Table 2-1 shows the actual monthly flow average values.

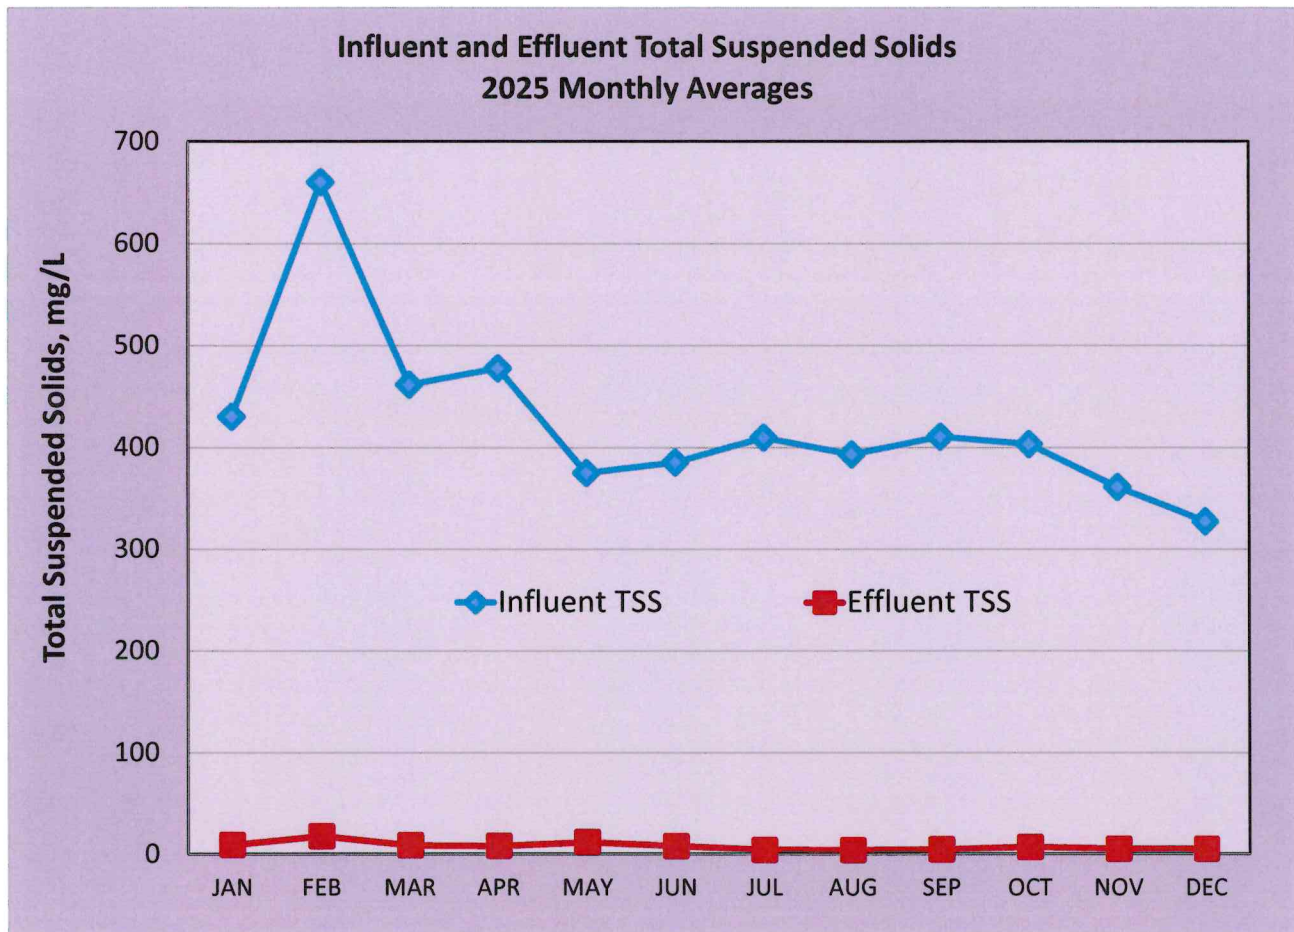
**Figure 2-3. Influent and Effluent Total Suspended Solids 2025 Monthly Averages**

Influent and effluent suspended solids were measured five days per week on 24-hour composite samples. The effectiveness of the treatment plant in removing suspended solids is demonstrated by the variation of influent solids versus the low-level and consistent output of effluent solids (see Figure 2-3). Influent suspended solids concentrations averaged 424 mg/L for the year showing a slight decrease from the 2024 annual average of 434 mg/L. Figure 2-3 shows a fluctuation in concentration of suspended solids that occurred during the year. The treatment process reduced the concentration of total suspended solids in the effluent to an annual average of 7.8 mg/L which is a minor decrease from the 8.4 mg/L average of 2024.

All effluent 30-day monthly averages were well below the 30-mg/L monthly average limitation. Overall removal efficiency for the year was an average of 98.1 percent, see Table 2-1.

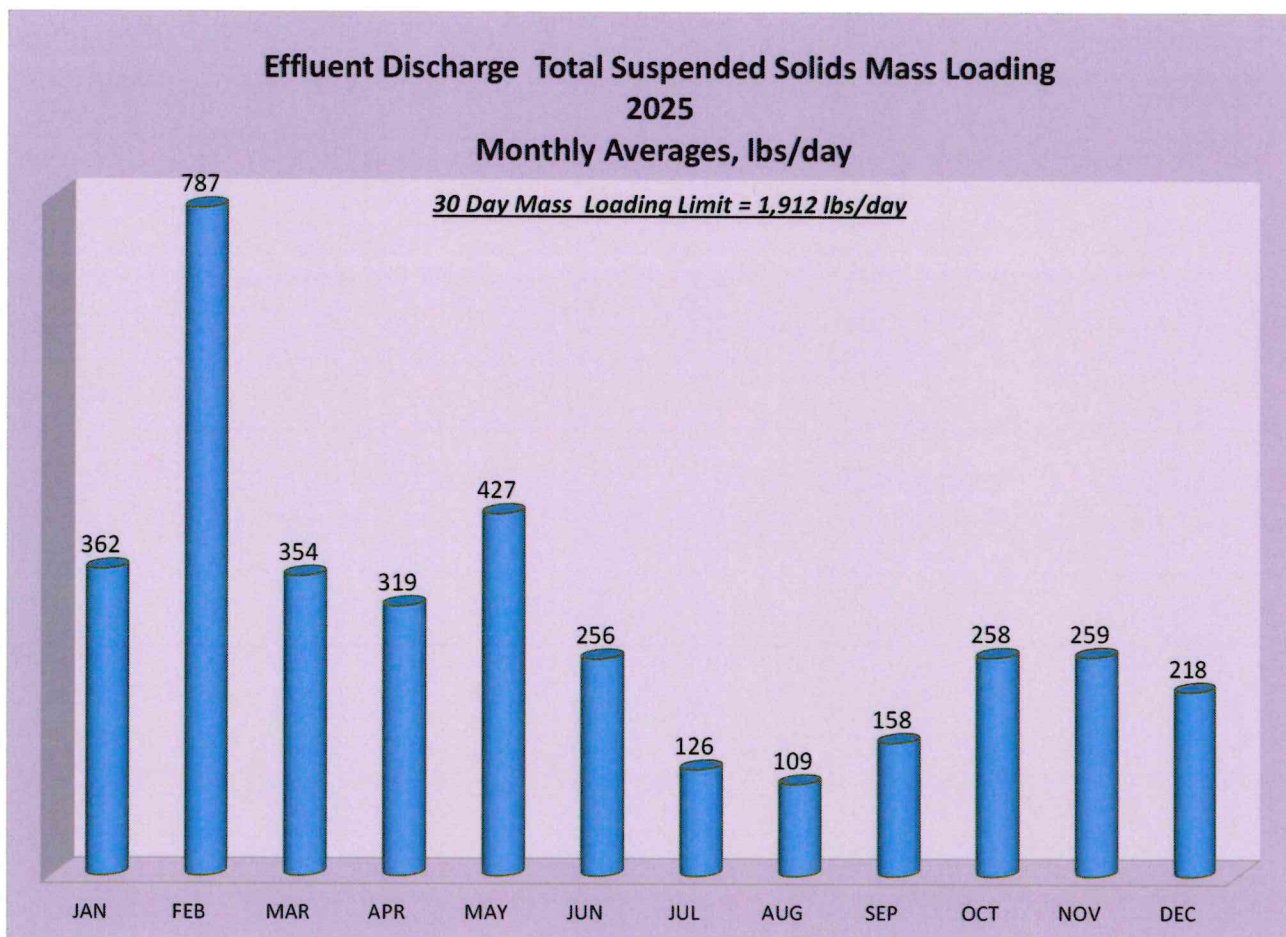
**Figure 2-4. Effluent Discharge Total Suspended Solids Mass Loading, 2025 Monthly Averages, lbs/day**

Average monthly suspended solids mass loading rates for 2025 are represented graphically in Figure 2-4. The mass emission limit is based on average dry weather flow (ADWF) and is a limit applied to dry weather flows (DWF). There is no limit for mass emissions on wet weather flows.

The maximum average monthly mass emission loading for 2025 occurred in February at a high of 787 lbs/day, which is approximately 41 percent of the permitted monthly 30-day average limit of 1,912 lbs/day. The average weekly limitation for suspended solids loading is 2,867 lbs/day. Loading rates were well below the discharge limits throughout the year.

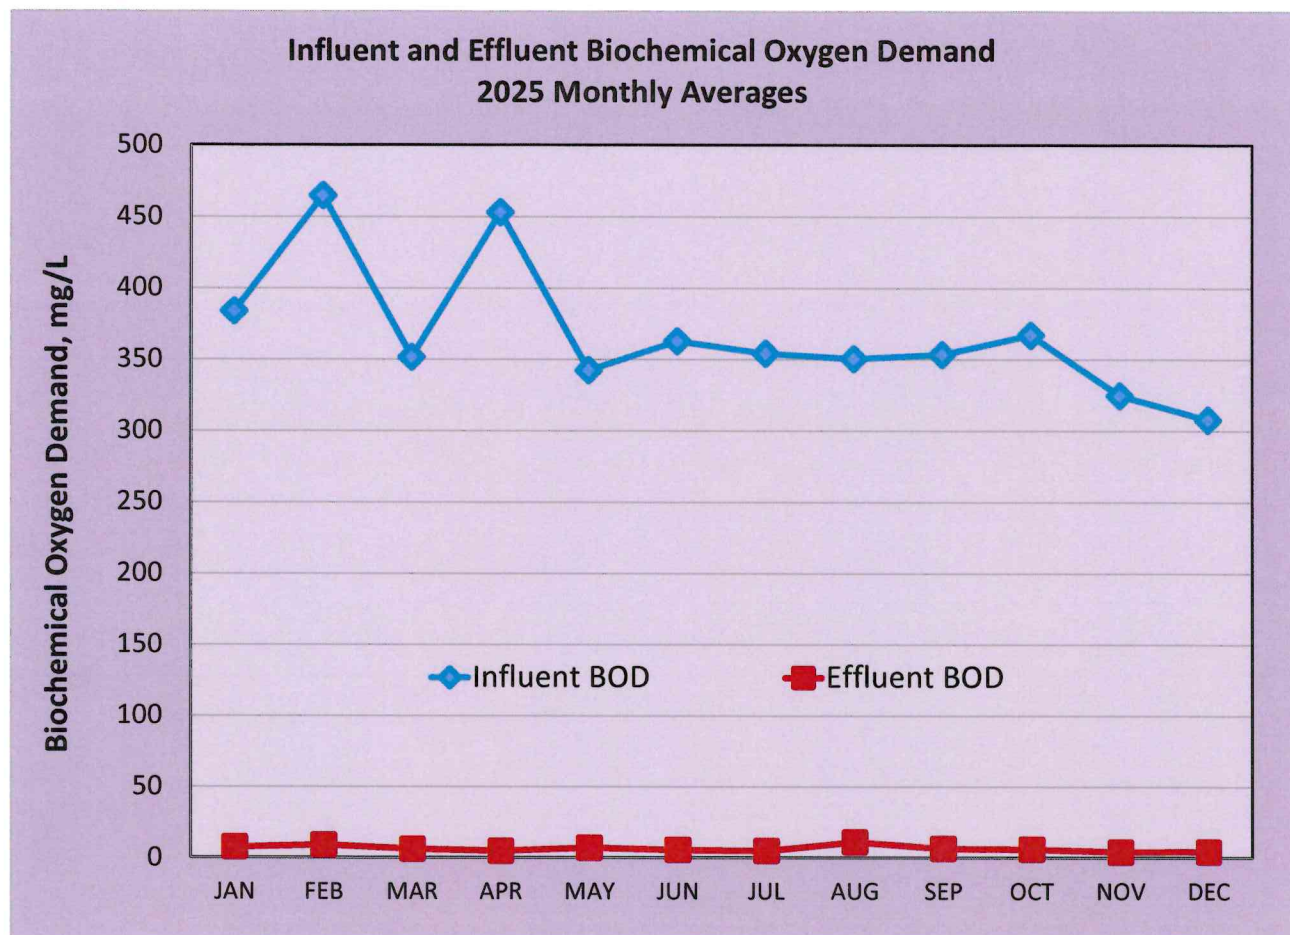
**Figure 2-5. Influent and Effluent Biochemical Oxygen Demand 2025 Monthly Averages**

During 2025 influent BOD averaged 368 mg/L showing an increase of 7% from the annual influent average of 343 mg/L for 2024. The influent BOD varied throughout the year, ranging from a monthly average low of 308 mg/L in December to a high of 465 mg/L in February. Variations in the monthly average final effluent BOD concentration were observed throughout the year with the annual average of 6.6 mg/L and the range extending from a low of 4.3 mg/L in November to a high of 11.2 mg/L in August, (Table 2-1). The difference between influent and effluent BOD represents an average overall removal rate of 98.1 percent.

The NPDES R3-2017-0021 permit limits are an average of 30 mg/L and weekly average of 45 mg/L. All BOD NPDES limitations were achieved throughout the year.

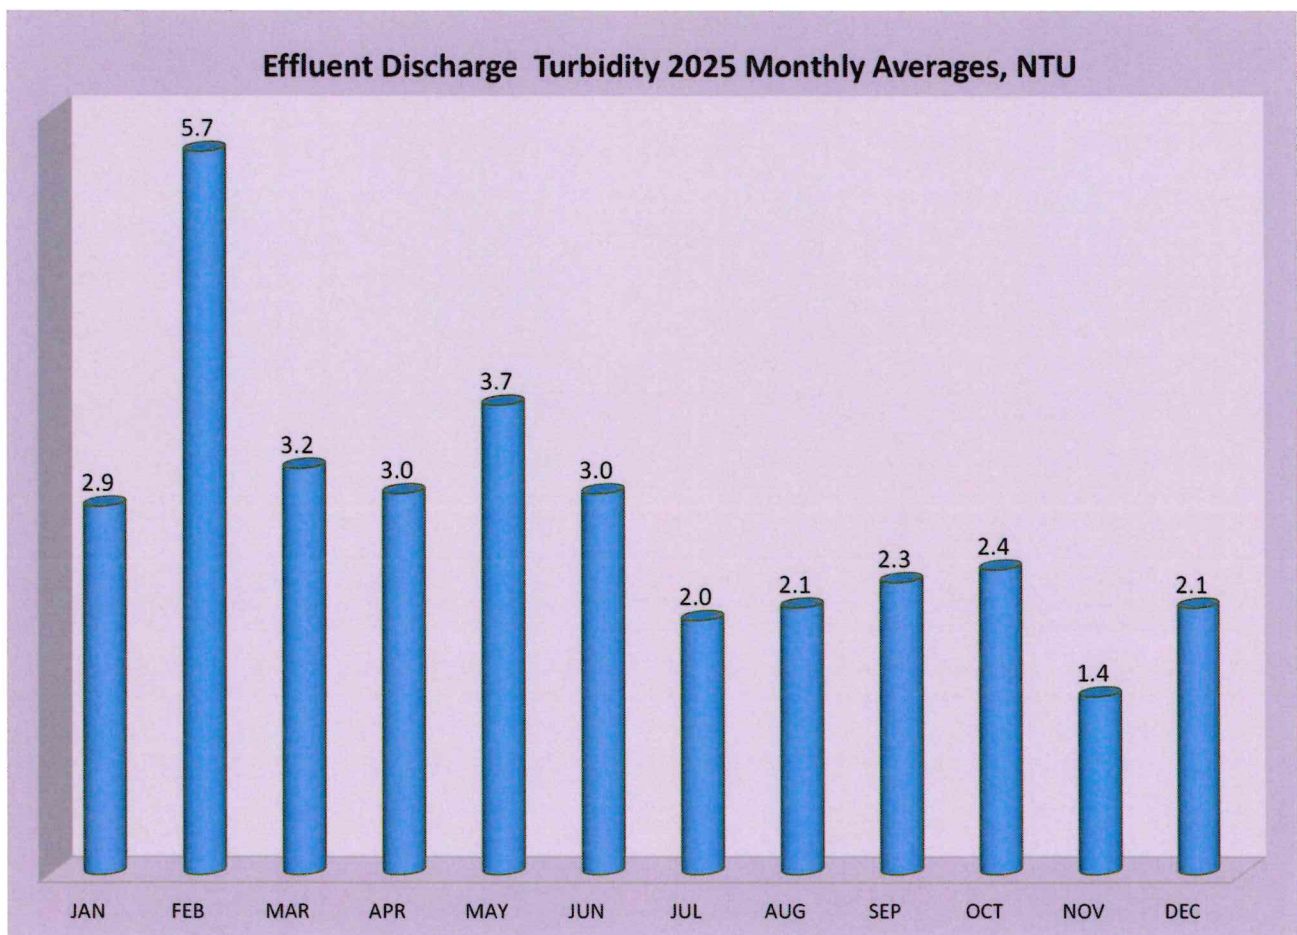
**Figure 2-6. Effluent Discharge Turbidity 2025 Monthly Averages, NTU**

Effluent turbidity was monitored five days per week. The permit limitations for effluent turbidity consists of a monthly average of 75 Nephelometric Turbidity Units (NTU), a weekly average of 100 NTU, and a maximum at any time limitation of 225 NTU. Effluent turbidity data are shown graphically in Figure 2-6. The maximum value at any time, 18.6 NTU, occurred on February 4<sup>th</sup> which was still well below the effluent limits. Monthly averages ranged from a low of 1.4 NTU to a high of 5.7 NTU. All values were significantly below their respective permit limitations.

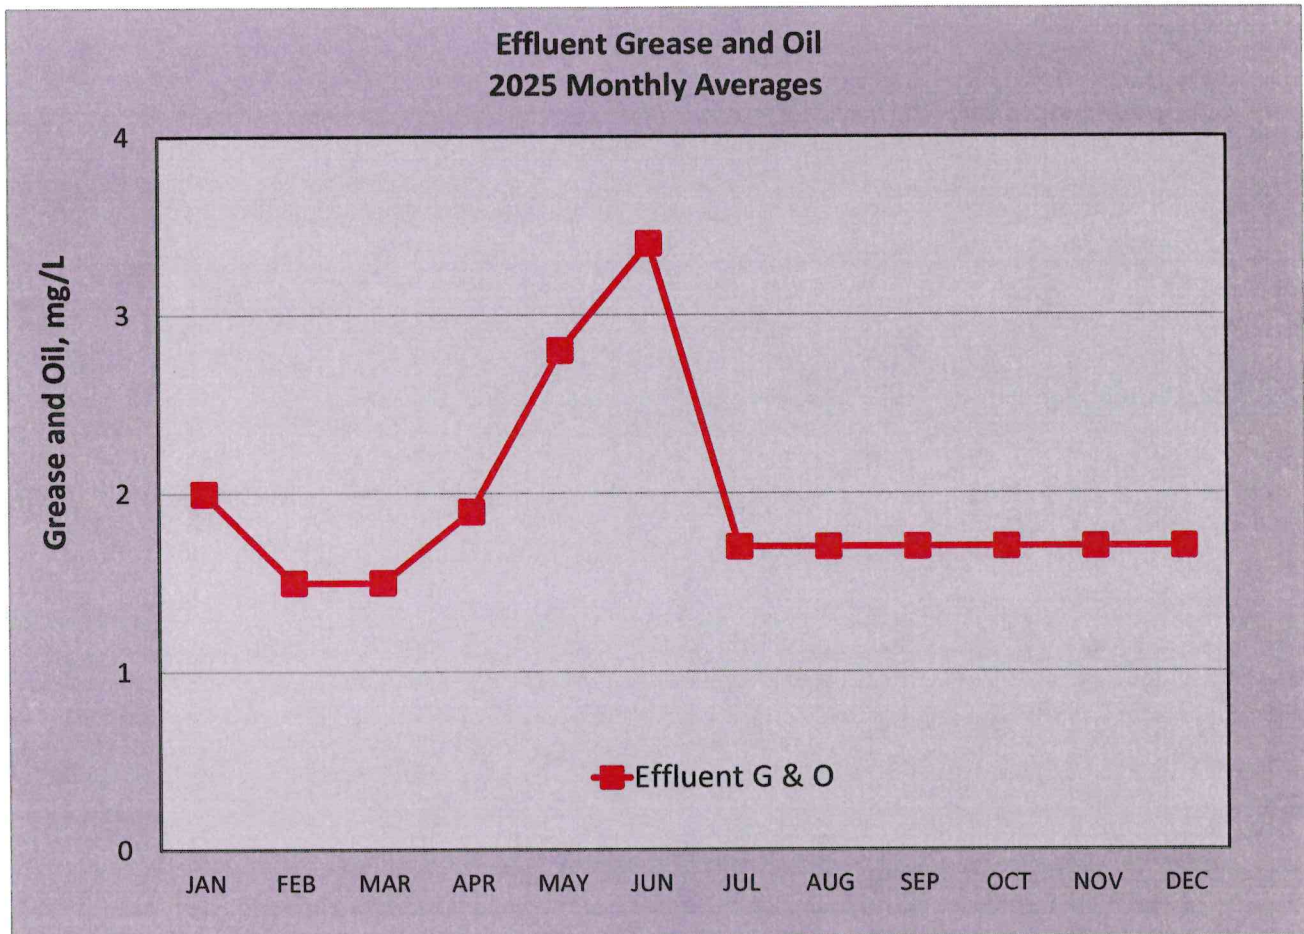
**Figure 2-7. Effluent Grease and Oil 2025 Monthly Averages**

Effluent oil and grease were monitored weekly. Monthly average results are shown graphically in Figure 2-7. Prior to August 2007 Freon was the solvent used in the standard method to extract oil and greases from water samples. According to EPA regulations, in August 2007 the GSD laboratory ceased using Freon as the extraction solvent and began using hexane as the required solvent. The District continued to use the liquid-liquid extraction method, the only change at this time was the solvent. In December 2010, the GSD laboratory began analyzing for oil and grease using the approved standard solid phase extraction (SPE) EPA 1664 method. However, oil and grease samples were also subcontracted to OEC during the year. The current permit, R3-2017-0021, eliminated the influent oil and grease monitoring requirement.

Effluent grease and oil concentrations were low during 2025. All monthly, weekly, and maximum permit limits were met. Mass emissions values ranged from a monthly average low of 46 lbs/day in January to a high of 128 lbs/day in June. Both are well below the permit limitation of 1,590 lbs/day. Monthly average oil and grease concentrations in the effluent ranged from below the reporting limit of (1.5 or 1.7) mg/L to 3.4 mg/L. See Table 2-2 for a visual representation of the monthly average results. All permit limitations for effluent oil and grease were met during 2025.

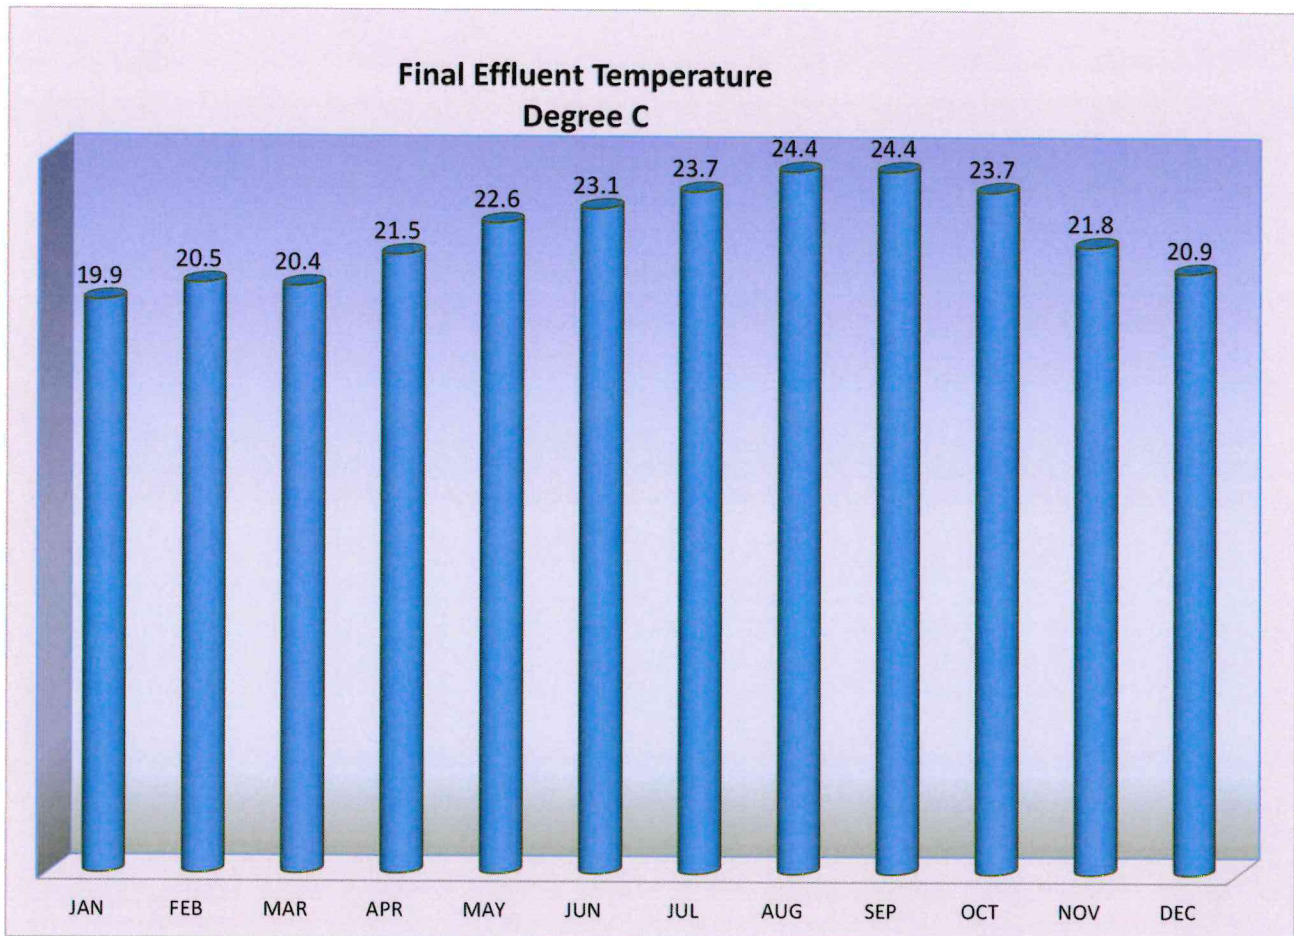
**Figure 2-8. Effluent Discharge Temperature 2025 Monthly Averages**

Effluent temperature was sampled five days per week throughout 2025. The data reflect a typical response to seasonal changes (Figure 2-8). The coolest temperatures occurred during January with average monthly temperatures of 19.9 ° C. A warming trend continued throughout the summer and fall months to reach a monthly averaged high of 24.4 ° C in August and September. The year began with the coolest average temperatures and ended with a cooling trend.
